End-User Alert

B. Braun Infusomat® Space® Pump Admin Sets

This information is provided in line with the recommendations from B. Braun Urgent Medical Device Correction Notice dated Oct. 23, 2023. The purpose is intended to support end-users until such time that replacement products are available.

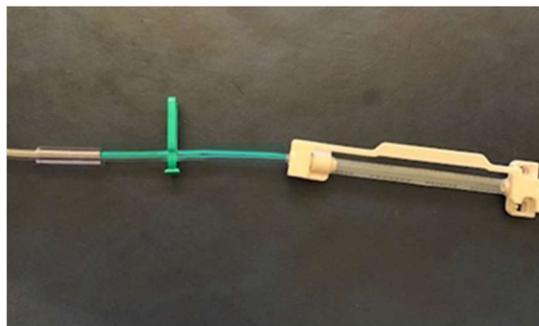
Reason for Correction Notice: Sets within the lot number range, **MAY** have tubing with varying outer diameters and/or length too short resulting in a need to stretch the tubing to properly fit with the Pump. This may result in possible false air-in-line alarm.

- a. Inspect outer diameter of the tubing segment just to the left of the silastic tubing segment (highlighted in green) prior to use, looking & feeling for variation in the tube diameter (i.e.: tubing will be wider/narrower in some sections, inconsistent).
 - b. Pay attention to the length of the same segment, if you have to stretch the tubing to load it, then it is too short, do not use it.
3. When infusing high risk medications (e.g. vasopressors) or infusion with acute clinical effects (e.g. electrolytes):
 - a. If possible, have a second pump with an administration set available for exchange in the event of a false alarm and:
 - Swap out pump with another from your site's/program's supply;
 - Send alarming pump to your site Biomed/Clinical Engineering Department; and

1. **If an alarm is ringing on the pump, always respond to the alarm by checking your patient first, then the pump and if it does not clear after following all the steps you were trained on. (See #5 reference list below).**
2. **Inspect tubing before use.** Do not use tubing with a noticeably smaller outer diameter or which needs to be stretched to fit within the Infusomat® Space® Pump.
