Patient Safety Alert

Re: **B Braun - Crimping found in the IV tubing may contribute to false alarms**

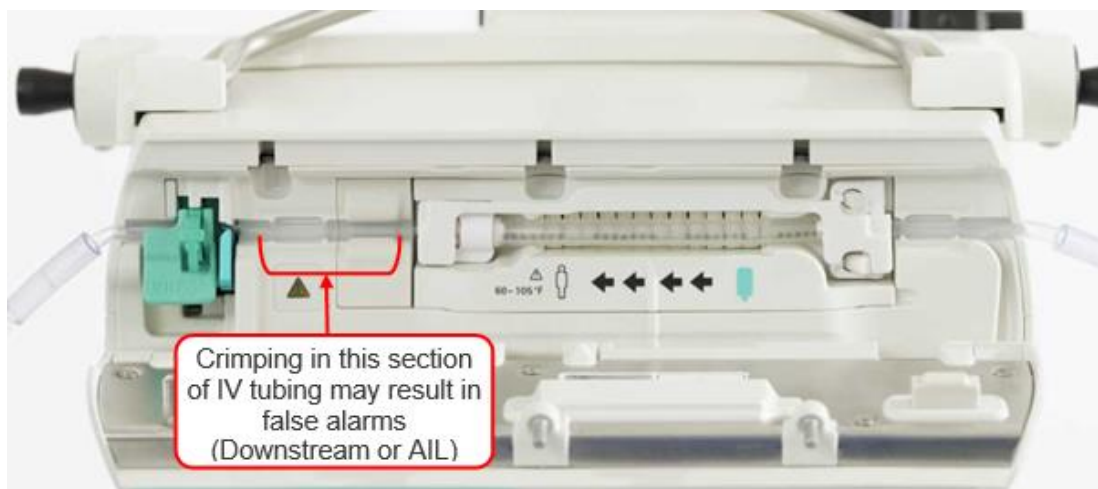
Clinical Engineering has conducted some tests and have demonstrated that crimping of the IV sets interferes with readings from the AIL sensor. Readings from the sensor improve once tubing has been rolled between fingers to improve shape.

- Assess the IV tubing for crimps in the line upon opening the package
- If crimping is found in the pump sensor zone, attempt to return tubing to normal shape by rolling tubing between fingers
- If this is not successful, and you and your team consider the depth of the crimp to be severe don't use the IV tubing
- Place the IV tubing set that can't be used and its packaging into your unit's identified bin to facilitate follow-up with the supplier
- Alert your site's Supply Chain if your unit is finding that the majority of the IV tubing in your supply room unusable
- Continue to complete safety events/occurrence reporting and vendor product complaint forms for safety events that reach the patient
