SAFER PRACTICE NOTICE

IV Med Flushing Practices and Urgent Correction

Notice for B Braun backcheck Valve

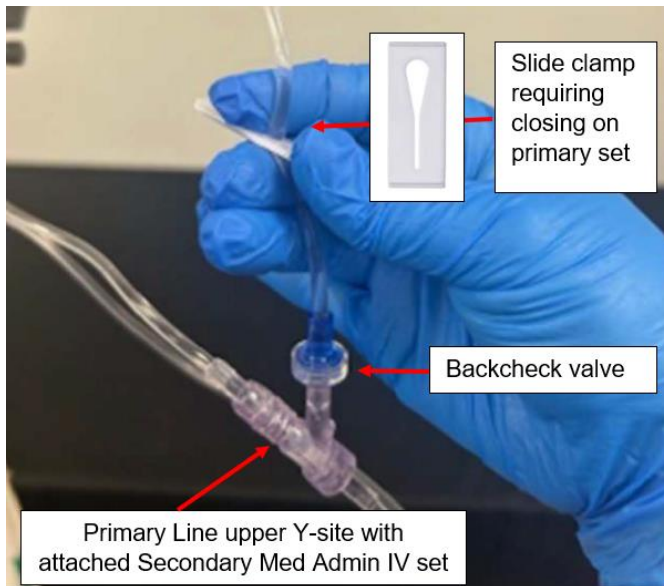
Issue: B Braun has issued a voluntary Urgent Medical Device Correction for IV administration sets due to the potential for the backcheck valve to malfunction causing backflow of medication from a secondary infusion (piggyback) into a primary IV line. It may also cause an inability to prime the tubing. The backcheck valve above the upper Y-site used to infuse medication is the affected component. The backcheck valve may malfunction when its valve remains:

- Stuck in the open position resulting in the backflow of medication from the secondary set into primary bag
- Stuck in the fully closed position resulting in inability to prime the IV set

Immediate Interim Measures for Patient Safety

1. Clamp primary line using slide clamp when delivering meds by secondary infusion sets via pump
2. Change pump programming mode to Manual (see instruction below) for an audible alarm when secondary med total VTBI is completed
3. Program a med flush, up to 1/3rd (one-third) of the dose remains in the primary IV line
4. Unclamp the primary IV tubing and Press **Start** to infuse the **PRIMary** line
